Contract #: 04-0120F4Cty: SF/ALA Rte: 80 PM: 13.2/13.9File #: 99.28**WELDING INSPECTION REPORT****Resident Engineer:** Casey, William**Address:** 333 Burma Road**City:** Oakland, CA 94607**Report No:** WIR-029151**Date Inspected:** 20-Feb-2013**Project Name:** SAS Superstructure**OSM Arrival Time:** 700**Prime Contractor:** American Bridge/Fluor Enterprises, a JV**OSM Departure Time:** 1530**Contractor:** USA Hoist**Location:** USA Hoist, Crest Hill, IL

Bridge No: 34-0006**Component:** SAS Tower Elevator**Summary of Items Observed:**

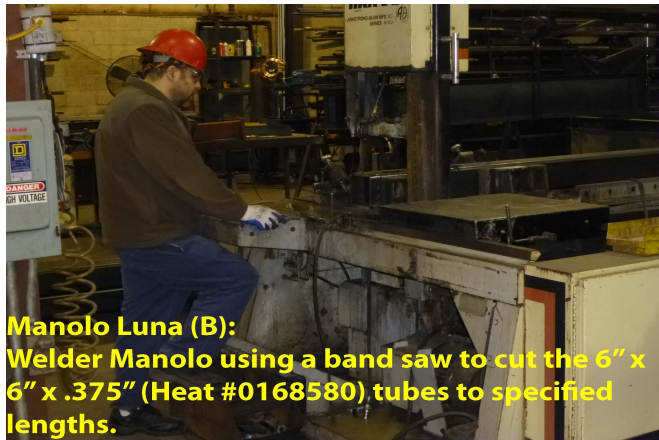
Welder was observed machine cutting 6" x 6" x .375" tubular steel (Heat#0168580) for the elevator tower. At the end of the shift approximately 7 tubes had been cut using a band saw yielding 14 tubes total cut to length specified. Cutting will continue on the following shift.

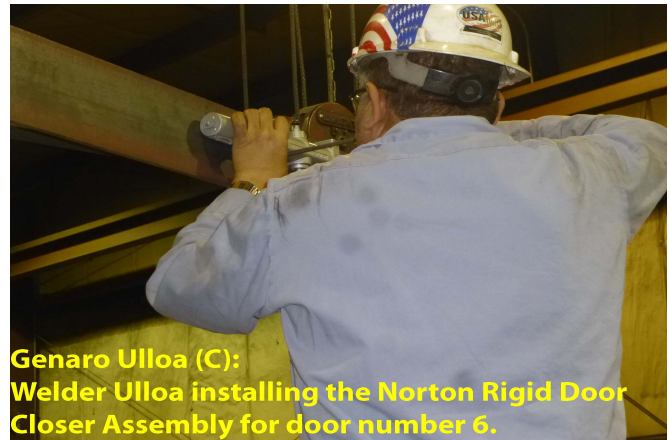
Welder was observed fitting and tack welding the middle hinge to the door and door frame assembly for door number 6 and adjusting the Door Safety Interlock mechanism until the lock engagement was satisfactory. Afterwards the welder proceeded to drill the bolt holes onto the top rail of door number 6 for the door closer. After drilling the four (4) 3/16" diameter bolt holes on the top rail the welder then tapped them with 1/4"-20 UNC. Upon completion of tapping the bolts holes the welder Ulloa then installed the Norton Rigid Door Closer Assembly. The welder was noted using gas shielded FCAW-G with 1.1mm E71T-1C Familiarc DW-50 wire electrode implementing USA Hoist Welding Procedure Specification FCAW3210. The shielding gas being used was noted a combination of 75% Argon and 25% CO2 with flow rate of 35 CFH. During the shift, the welding parameters were measured 26 volts and 196 amperes which deemed in compliance to the project requirements.

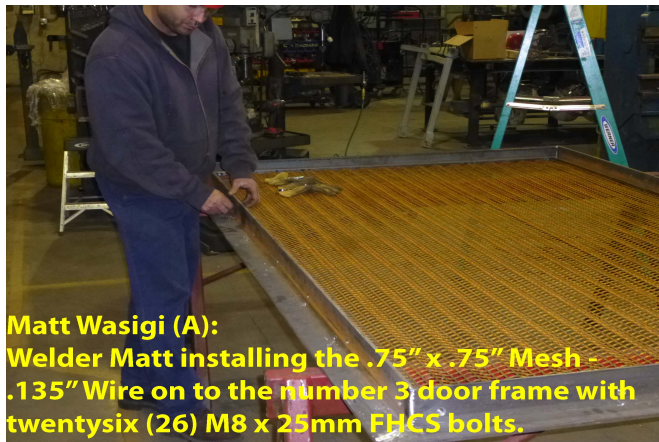
Welder was observed trial fitting by installing the steel wire mesh (.75" x .75" x .135" Wire with Plain Steel C-Channel Frames: 1" Wide x 16 Ga. with 5/16" – 18 Hex Nuts welded to inside of frame) from Flynn & Enslow Inc. for door number 3 by drilling holes for the M8 x 25MM LG, FHCS bolts at locations corresponding to the M8 HEX nuts welded to the door wire mesh frame assembly. (Ref. Dwg. 914926)
